EXPERIMENTAL RESULTS AND DISCUSSION

5.1 DATA GATHERED

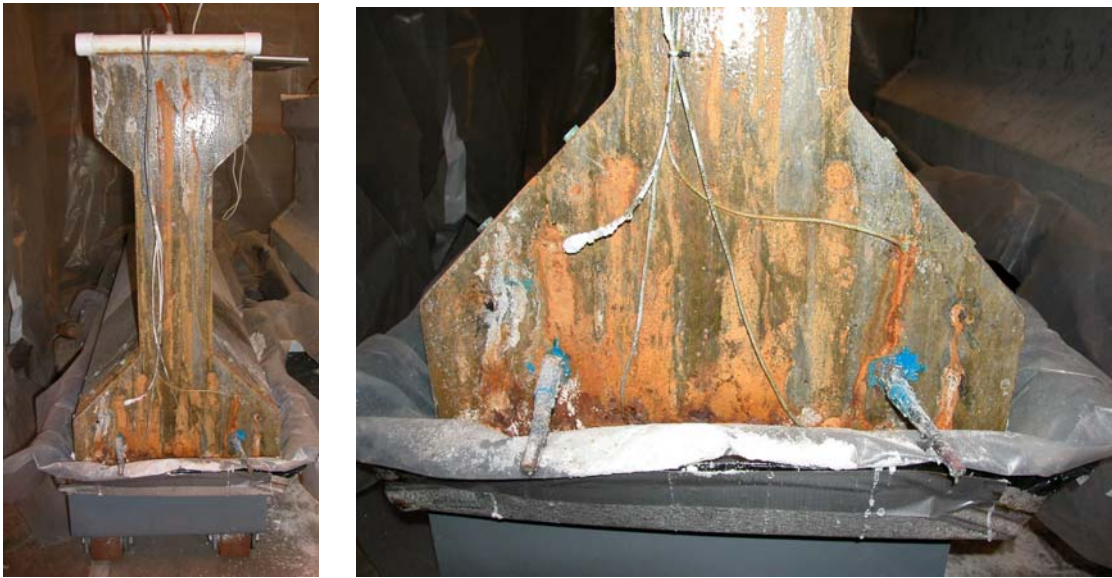
Figure 60. Beam 1: West (pre-coated) Beam-End 1A (after 6 months)

west end (1A) initially. Figure 60 illustrates the condition of 1A (pre-coated end) after 6 months of exposure. Figure 61 illustrates the condition of the southwest and northwest faces. Figure 62 illustrates the condition of the east end 1B after 6 months of exposure. Figure 63 illustrates the condition of the southeast and northeast faces.

At the completion of the first exposure cycle the beam-ends had heavy salt residue along the front faces and on some portions of the bottom flanges. Rust stains were also evident along the path of the salt water. No major spalling or cracking was observed. Some flaking of concrete was observed at the corners of the beam. In addition, corrosion products were observed on the exposed tendon ends, and were found to increase in amount over the course of the exposure.

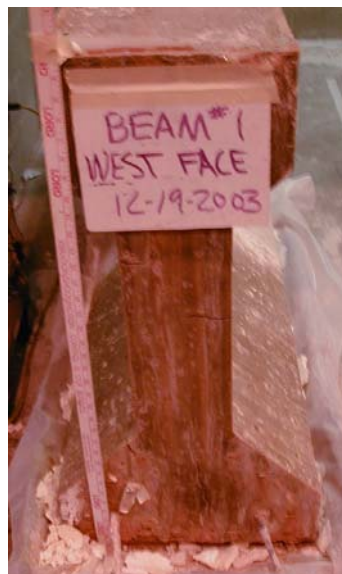
Figure 64. Beam End 1A: West End (pre-epoxy coated)(after 18 months)

ground and thoroughly washed to remove all debris. The surface preparation and surface treatment application information was detailed in section 4.8. The east end (1B) was then treated with the epoxy coating. Figure 64 illustrates the condition of the west end (1A) after 18 months of exposure. Figure 65 illustrates the condition of the southwest side at the west end 1A. Figure 66 illustrates the condition of the east end face and southeast side of 1B (post-coated) after 18 months of exposure. Since the first 6-month exposure cycle did not result in the concrete spalling or significant tendon corrosion (section 5.1.4), the configuration of the saltwater dispersion system was altered slightly to increase the likelihood of corrosion after the second 6-month cycle. Pipes (1 foot long) were added along the north and south sides of each beam end to allow salt water to flow along the side face of the beams. The altered salt-water distribution setup was able to disperse water to both the sides and face of the beams. In addition, due to the new setup all of the beams were exposed to more water at a slightly faster flow rate.

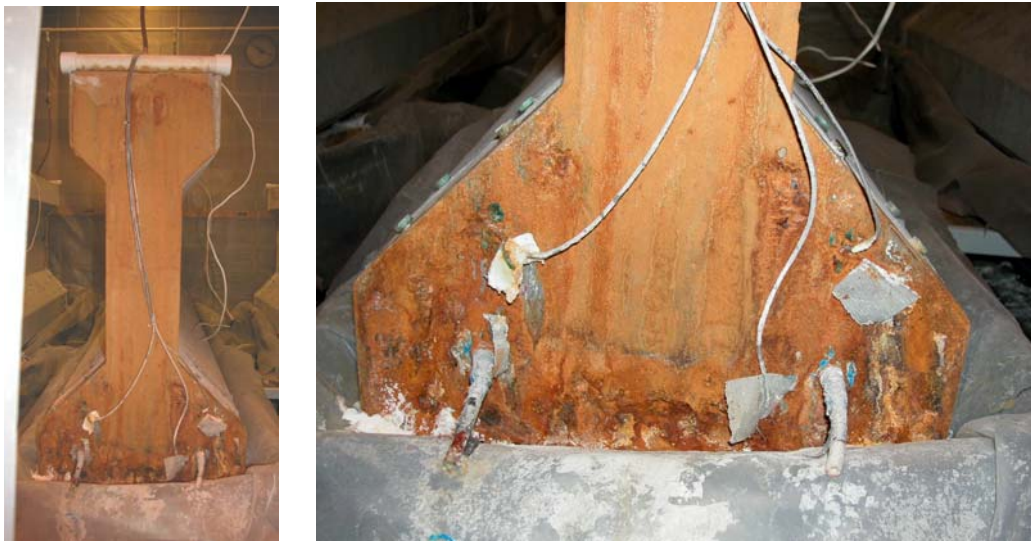
Figure 67. Beam End 2A: West End (untreated)(After 6 months)

Both the west (2A) and east (2B) ends remained untreated for the first exposure cycle. After 6 months of exposure, portions of concrete were removed from the east end to facilitate installation of a patch repair. Figure 67 illustrates the condition of the west (untreated end 2A) after 6 months of exposure. Figure 68 illustrates the condition of the southwest face. Figure 69 illustrates the condition of the east (untreated end) after 6 months of exposure. Figure 70 illustrates the condition of the southeast and northeast faces.

At completion of the first exposure cycle the beams-ends had heavy salt residue along the front faces and on some portions of the bottom flanges. Rust stains were also evident along the path of the salt water. No major spalling or cracking was observed. Some flaking of concrete was observed at the corners or edges of the beam. In addition, corrosion products were observed on the exposed tendon ends, and were found to increase in amount over the course of the exposure.

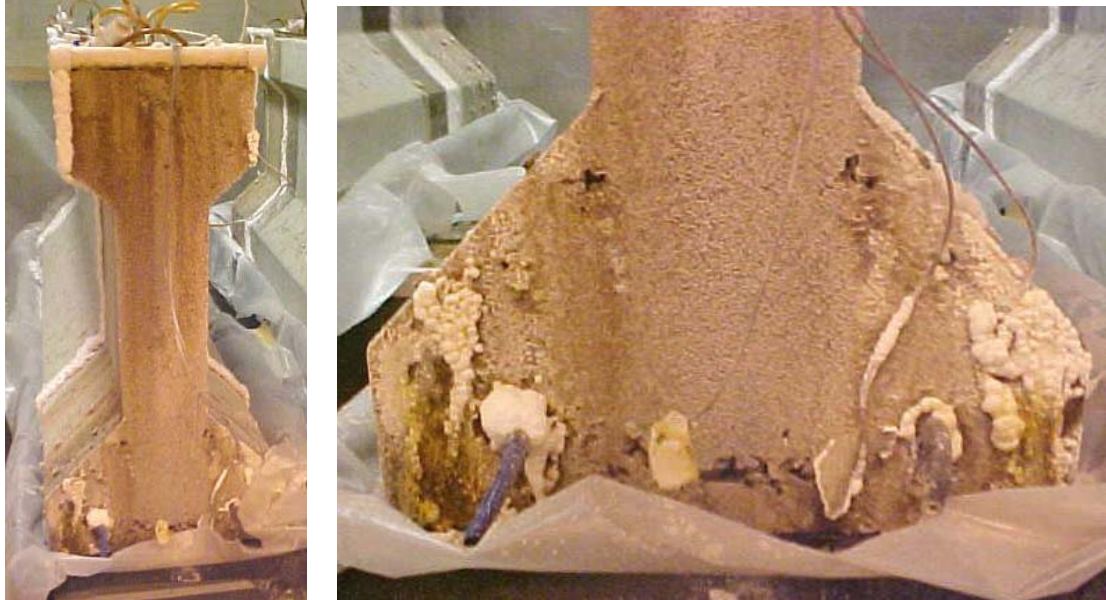
Figure 74. Beam End 2A: West End (untreated) (After 10 months)

Figure 74 illustrates the condition of the west (untreated) after 10 months of exposure. Figure 75 illustrates the condition of the southwest and northwest faces after 18 months of exposure.

After 10 months of corrosion exposure, the beam-ends of beam 2 were experiencing significant rust staining and salt residue. No spalling or major cracking was observed on the untreated (west) end. However, since the end was covered heavily in salt deposits, it was difficult to observe whether or not small hairline cracks were occurring. The patched (east) end experienced no major spalling, but cracks were observed in the patched region of the beam. Also, a vertical crack running the full height of the center section of the southeast end

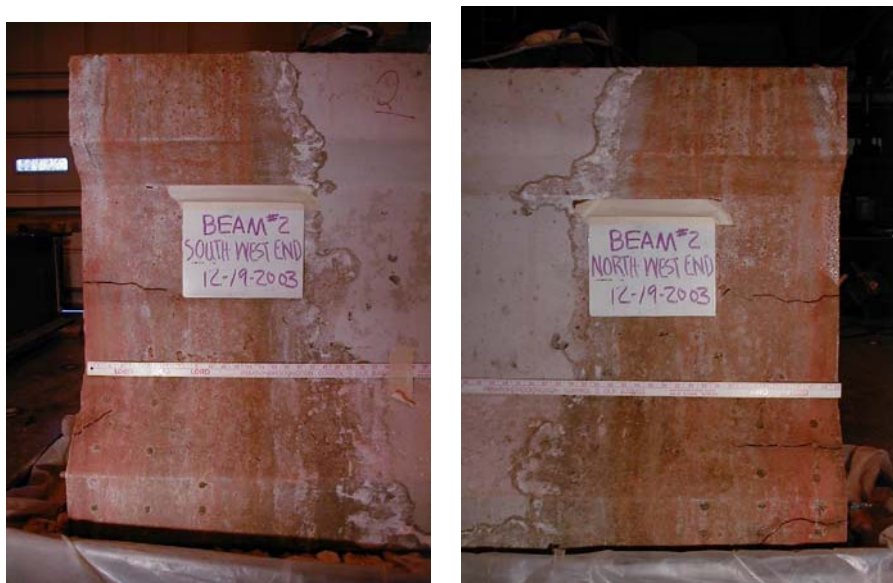
Figure 75. Beam End 2A: Southwest Face (left), Northwest Face (right) (After 18 months)

At the conclusion of testing (after 18 months of exposure), both ends of beam 2 had developed extensive cracking and corrosion stains were evident. All crack maps are shown in section 5.3 of this report.

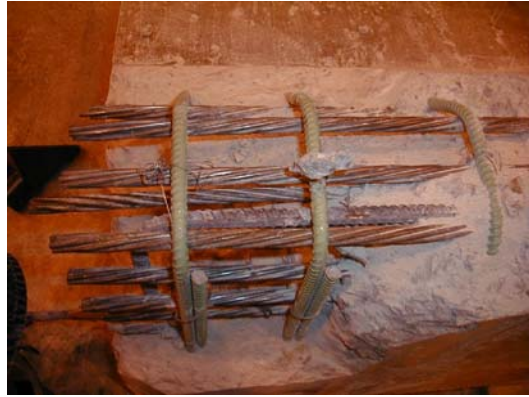
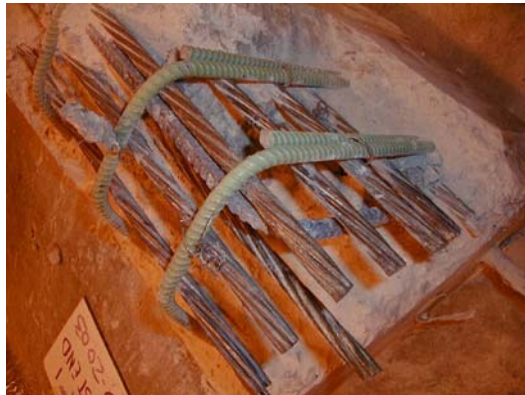
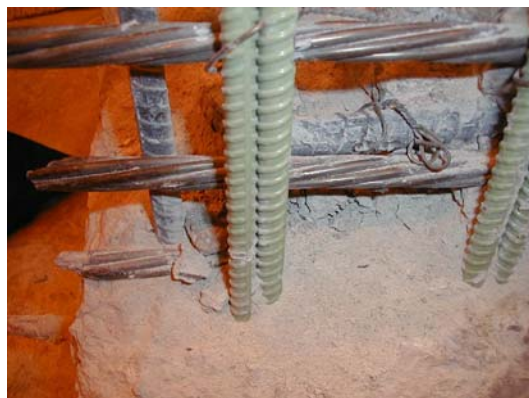
Figure 117. Beam End 1A – Treated With Epoxy Coating From Day 1

Beam End	Description	Side Strand	Bottom Strand	Ave. Rating
1A	Epoxy Coated From Day 1	2	4	3
1B	Epoxy Coated After 6 Months of Exposure	7	7	7
2A	No Treatment Applied	4	7	5.5
2B	Patch Repair After 6 Months of Exposure	8	8	8
3A	Silane Sealer Applied from Day 1	2	5	3.5
3B	Silane Sealer Applied After 6 Months of Exposure	5	6	5.5
4A	Polymer Resin Coating Applied After 6 Months Exp.	6	6	6
4B	FRP Wrap Applied After 6 Months of Exposure	7	7	7
5A	Polymer Resin Coating Applied From Day 1	2	2	2
5B	FRP Wrap Applied From Day 1	1	3	2

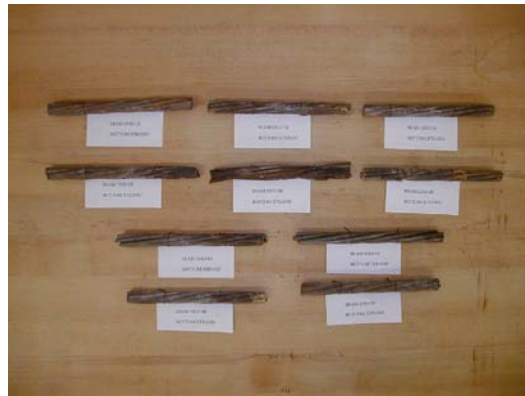
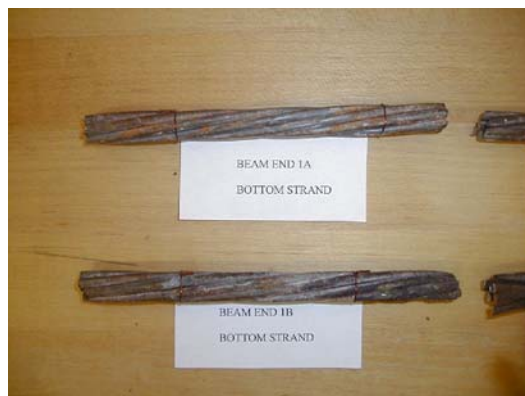
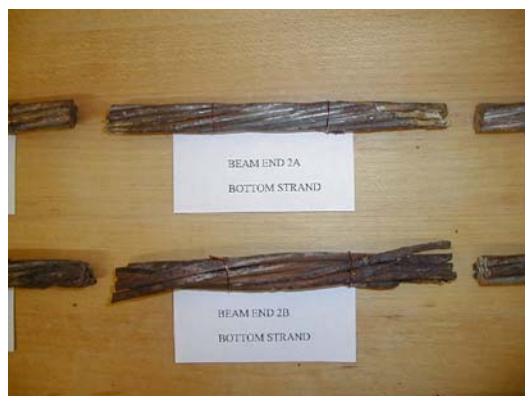
Figures 117 thru 128 show the condition of strands after dissection for all beam-ends. A numerical rating of bottom strand samples based on the PCI reference [55] are given in Table 33. Among the beam-ends treated from the first day, the FRP wrap and polymer resin coating were rated the best. For beam-ends treated after 6 months of exposure, the Silane sealer and polymer resin coating were judged the best with respect to strand corrosion.

Figure 127. Comparison of Strands with Respect to Corrosion

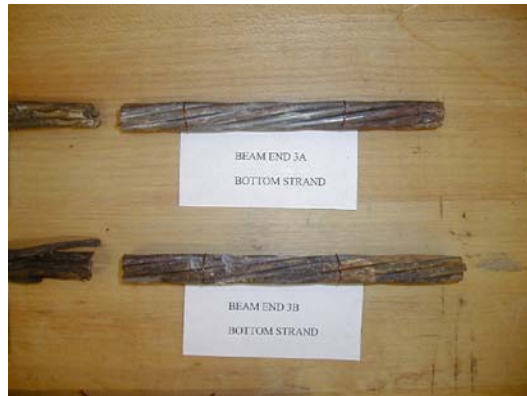
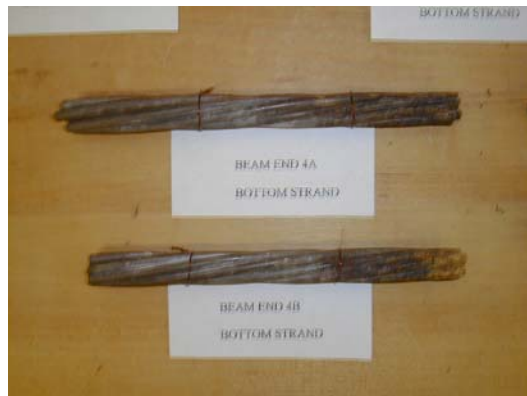
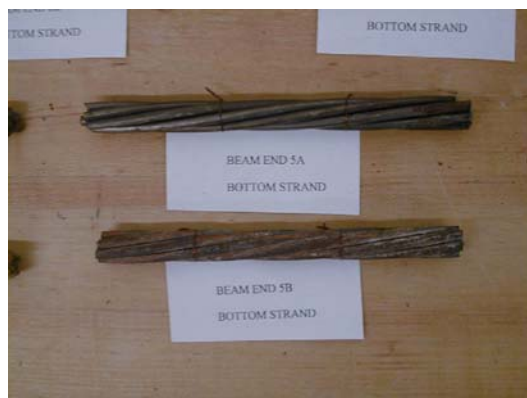
Figure 128. Comparison of Strands with Respect to Corrosion
